# **Troubleshooting Common System Configuration Issues**

## **Windows\* 95/98 INF Update Utility Bus Master IDE Driver for Windows 95**

*Revision 2.1  
August, 1998*

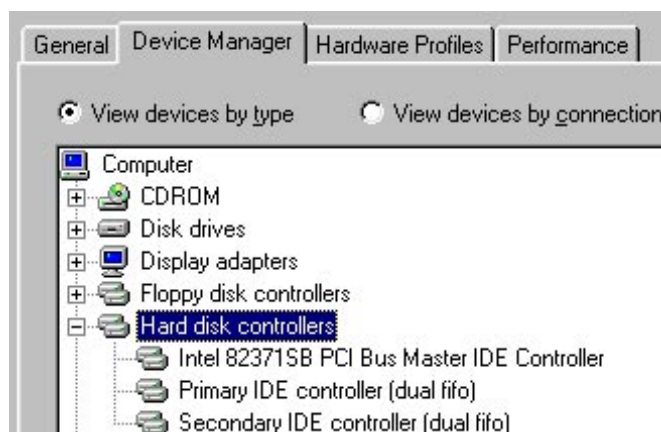
After installing the INF update utility, Device Manager should indicate your system is now using the Intel Hard Disk Controller driver (without the Intel Bus Master driver). The Hard Disk Controllers listing should show:

The entry for the Intel® 82371xB will correspond to the South Bridge (PIIX) component in your system. If these entries do not appear, or other symptoms are observed, see the following troubleshooting section. Note: xB can represent one of AB, SB, FB, or AB/EB, depending on the PIIXn component.
